**Flood Control Project Maintenance
Levee Inspections**
LMA District Cover Sheet
Spring 2017 Levee Inspection Results

Yolo County Service Area 6

Spring 2017 Levee Inspection Results

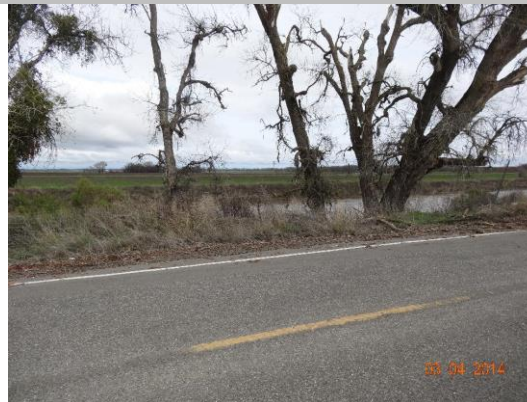
Photo 3 of 3 : UCIP_SP_2017_31986_58441.jpg

Item	DWR UCIP Field Study			38.765142 °	38.765142 °	
				-121.690963 °	-121.690963 °	
DWR ID						
Comment Code						
Inspector Comment						
FS_ID:31986						
DS_ID:19530						
EP_NO: 9409						
Repair Type: Non-Urgent						
Crossing Status: Found						
UCIP Comments: Pump station not found. Crossing appears to be abandon. Need to contact owner to determine status. Repair site on waterward side--waterward slope revegetated.						
FIELD_STRUCT_DESC: 16-inch steel pipe through the levee, 6.4 feet below the crown. Pump and control valve are located on the waterside (WS) bank. Ramp is located on landside (LS) slope. (Automatic Board Order (ABO) issued as Permit No. 9409, 1974 - Russell). [Additional Reference(s): DWR Levee Log, 1990 and 2005].						
FS Date: 3/4/2014

View of waterward side.

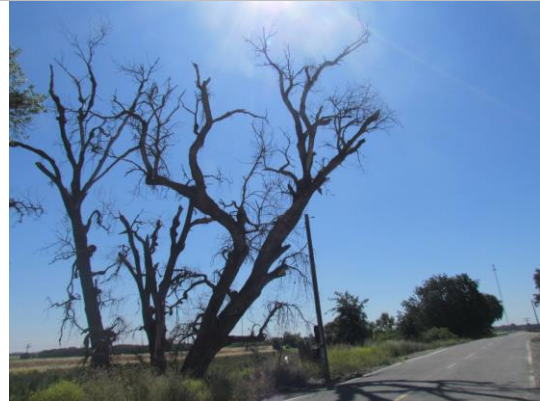
Photo 1 of 1 : SP_2017_NA0022_350_81_20170320_00062.jpg

LM Start	4.44	Rating **	M	Issue No.	81
LM End	4.44	Issue Type +	Ma	Location *	WS
Category	Earthen Levee			GPS Latitude/Longitude	
				Start	End
Item	Encroachments			38.765079 °	38.765079 °
				-121.690887 °	-121.690887 °
DWR ID	DWR_NA0022_01_s_2015_81				
Comment Code					
TR : Tree or limb					
Inspector Comment					
Fallen tree on waterside slope.

View of the dying tree on the waterward side of the levee looking downstream. Spring 2015.

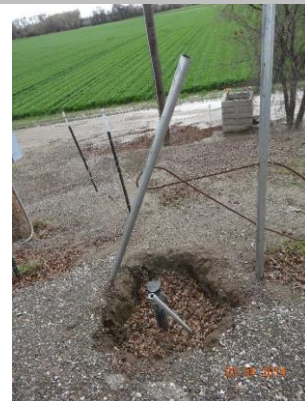
Photo 1 of 3 : UCIP_SP_2017_49983_69573.jpg

Comment Code					
Inspector Comment					
FS_ID:49983 DS_ID:19537 EP_NO: 18298 Repair Type: Urgent Crossing Status: Found UCIP Comments: 7/13/2016 same as last inspection - hole is still present near siphon breaker. Dense vegetation present and limits the inspector's visibility to identify signs of pipe failure (leaks) along the WS and LS slopes. Recommend removing vegetation along pipe alignment to conduct proper inspection of structure and appurtenances. (DWR UCIP - omagana)3/04/2014 Subsidence visible where siphon breaker is located on landward side. Unable to determine if subsidence is due to poor compaction or leak at siphon breaker. Need to contact owner to address issue. (DWR UCIP - omagana) FIELD_STRUCT_DESC: 14-inch steel water pipe through the levee, 2 feet below the levee crown. Pump platform is supported by 6 pilings located on the waterside (WS) slope. Siphon breaker and air release valve are located on the landside (LS) shoulder. Concrete distribution box is located on the LS toe. Rock riprap is used as armor along the WS slope. (Permit No. 18298, 2007 - Heidrick) FS Date: 7/13/2016

View of LS--subsidence near levee crown.

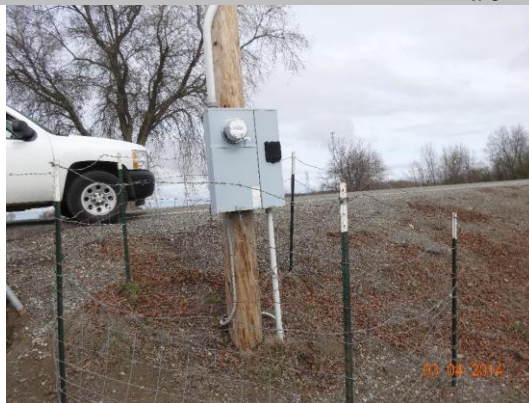
Photo 2 of 3 : UCIP_SP_2017_49983_69572.jpg

Item	DWR UCIP Field Study			38.764248 °		38.764248 °
				-121.689918 °		-121.689918 °
DWR ID						
Comment Code						
Inspector Comment						
FS_ID:49983 DS_ID:19537 EP_NO: 18298 Repair Type: Urgent Crossing Status: Found UCIP Comments: 7/13/2016 same as last inspection - hole is still present near siphon breaker. Dense vegetation present and limits the inspector's visibility to identify signs of pipe failure (leaks) along the WS and LS slopes. Recommend removing vegetation along pipe alignment to conduct proper inspection of structure and appurtenances. (DWR UCIP - omagana)3/04/2014 Subsidence visible where siphon breaker is located on landward side. Unable to determine if subsidence is due to poor compaction or leak at siphon breaker. Need to contact owner to address issue. (DWR UCIP - omagana) FIELD_STRUCT_DESC: 14-inch steel water pipe through the levee, 2 feet below the levee crown. Pump platform is supported by 6 pilings located on the waterside (WS) slope. Siphon breaker and air release valve are located on the landside (LS) shoulder. Concrete distribution box is located on the LS toe. Rock riprap is used as armor along the WS slope. (Permit No. 18298, 2007 - Heidrick) FS Date: 7/13/2016

Power pole with conduit line through levee.

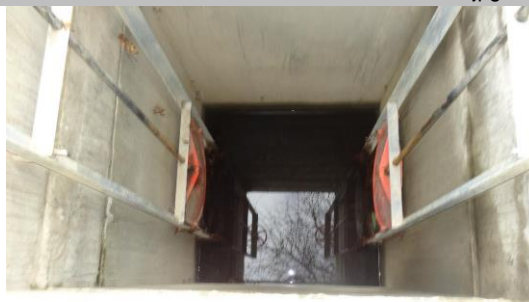
Photo 3 of 3 : UCIP_SP_2017_49983_69575.jpg

Inside view of concrete box located on LS toe.

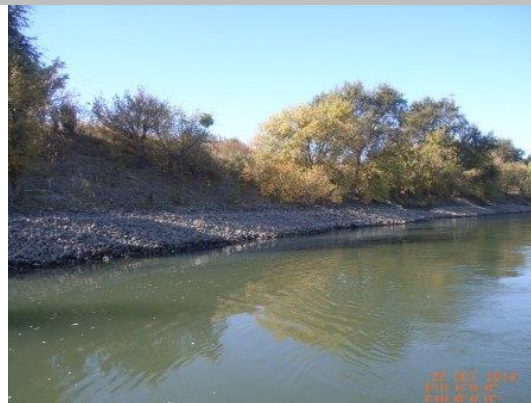
Photo 1 of 1 : SP_2017_NA0022_350_3_20170320_00002.jpg

LM Start	4.66	Rating **	M	Issue No.	3
LM End	4.86	Issue Type +	Ma	Location *	WS
Category	Supplemental			GPS Latitude/Longitude	
				Start	End
Item	2015 USACE Erosion Survey, DRAFT			38.763486 °	38.763313 °
				-121.687567 °	-121.684038 °
DWR ID	DWR_NA0022_01_s _ 2016_3				
Comment Code					
Inspector Comment					
2009 - Erosion into the levee toe. Some cobbles have been dumped into the erosion pockets. 2010 - Old cobble site starting to unravel. 2012 - Slope continues to steepen and new animal holes. 2013 - Downstream cobble is unraveling. 2015: No observed changes. [2015 Site ID: SAC_85-4_R]

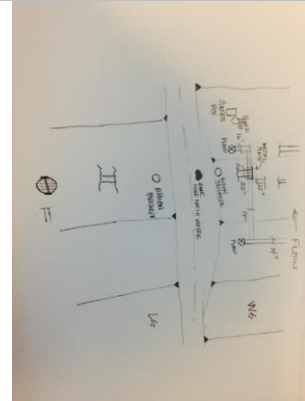
Photo 1 of 3 : UCIP_SP_2017_49984_58451.jpg

UCIP Comments: 7/13/2016 Same as last inspection. Sink hole repair visible on levee road. Recommend contacting owner to determine if an internal integrity inspection of the pipe was completed to confirm sink hole was not the cause of the damage to road. If no internal integrity inspection was completed during road repair, recommend an internal integrity inspection be completed at this location based on the sink hole that developed along pipe alignment and based on age of pipe. (DWR UCIP - omagana)3/04/2014 Signs of sink hole repair on levee crown. Owner will need to contact CVFPB to address sink hole repair. (DWR UCIP - omagana)

Plan view of crossing and appurtenances at CLM 4.692.

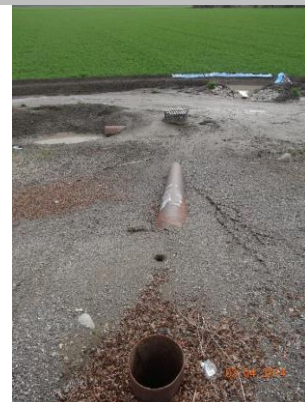
Photo 2 of 3 : UCIP_SP_2017_49984_58457.jpg

View of LS.

Item	DWR UCIP Field Study		38.763087 °	38.763087 °								
			-121.687125 °	-121.687125 °								
DWR ID												
Comment Code												
Inspector Comment												
FS_ID:49984 DS_ID:19531 EP_NO: 9408 Repair Type: Urgent Crossing Status: Found UCIP Comments: 7/13/2016 Same as last inspeciton. Sink hole repair visible on levee road. Recommend contacting owner to determine if an internal integrity inspection of the pipe was completed to confirm sink hole was not the cause of the damage to road. If no internal integrity inspection was completed during road repair, recommend an internal integrity inspection be completed at this location based on the sink hole that developed along pipe alignment and based on age of pipe. (DWR UCIP - omagana)3/04/2014 Signs of sink hole repair on levee crown. Owner will need to contact CVFPB to address sink hole repair. (DWR UCIP - omagana) FIELD_STRUCT_DESC: 20-inch steel pipe through the levee, 4.7 feet below the crown. Two slant pumps located on the waterside (WS) slope. Two steel protective housing units are located on lanside (LS) shoulder and WS shoulder. Ramp is located on LS slope. (Automatic Board Order (ABO) issued as Permit No. 9408, 1974 - Davidella, Grace and Florence Hershey, Estates). [Additional Reference(s): DWR Levee Log, 1955, 1990, and 2005]. FS Date: 7/13/2016

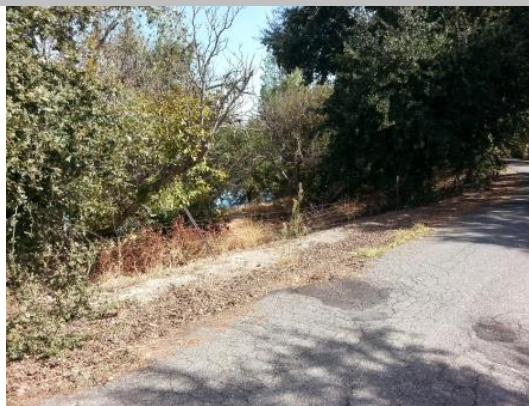
Photo 1 of 1 : SP_2017_NA0022_350_145_20170320_00097.jpg

LM Start	5.28	Rating **	M	Issue No.	145
LM End	5.47	Issue Type +	En	Location *	WS
Category	Earthen Levee			GPS Latitude/Longitude	
				Start	End
Item	Encroachments			38.760056 °	38.759670 °
				-121.677844 °	-121.674506 °
DWR ID	DWR_NA0022_01_f_2016_145				
Comment Code					
FE : Fence					
Inspector Comment

Fence on WS slope near levee crown. Fall inspection 10/07/2016.

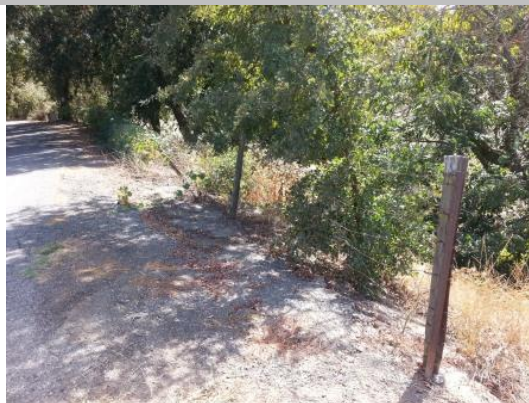
Photo 1 of 1 : SP_2017_NA0022_350_144_20170320_00096.jpg

LM Start	5.28	Rating **	M	Issue No.	144
LM End	5.47	Issue Type +	En	Location *	LS
Category	Earthen Levee			GPS Latitude/Longitude	
				Start	End
Item	Encroachments			38.760047 °	38.759669 °
				-121.677828 °	-121.674507 °
DWR ID	DWR_NA0022_01_f_2016_144				
Comment Code					
FE : Fence					
Inspector Comment

Fence on LS slope near levee crown. Fall inspection 10/07/2016.

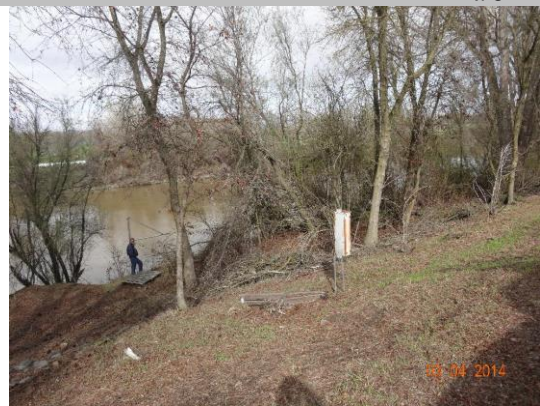
Photo 1 of 3 : UCIP_SP_2017_31927_58332.jpg

Comment Code					
Inspector Comment					
FS_ID:31927					
DS_ID:19532					
EP_NO: 3811					
Repair Type: Non-Urgent					
Crossing Status: Found					
UCIP Comments: Unable to confirm is crossing is still in use. Need to contact owner to determine status of crossing.					
FIELD_STRUCT_DESC: 10-inch steel irrigation pipe through the levee, 3.6 feet below the crown. Pump is located at toe of waterside (WS) slope, on bank of river. Standard cutoff wall around pipe at center of levee. Standpipe is located at the toe of landside (LS) slope. Siphon breaker is located on the LS shoulder. This crossing replaces the previous USACE O&M irrigation pipe referenced at Station 27+49. (Permit No. 3811, 1962 - Inglin) [Additional Reference(s): DWR Levee Log, 1990 and 2005. USACE Sacramento O&M Manual Unit No. 127, June 1953, (Station 27+49)].					
FS Date: 3/4/2014

View of waterward side.

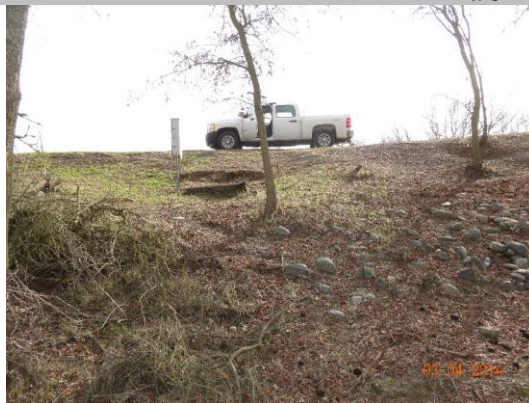
Photo 2 of 3 : UCIP_SP_2017_31927_58331.jpg

FS_ID:31927
DS_ID:19532
EP_NO: 3811
Repair Type: Non-Urgent
Crossing Status: Found
UCIP Comments: Unable to confirm is crossing is still in use. Need to contact owner to determine status of crossing.
FIELD_STRUCT_DESC: 10-inch steel irrigation pipe through the levee, 3.6 feet below the crown. Pump is located at toe of waterside (WS) slope, on bank of river. Standard cutoff wall around pipe at center of levee. Standpipe is located at the toe of landside (LS) slope. Siphon breaker is located on the LS shoulder. This crossing replaces the previous USACE O&M irrigation pipe referenced at Station 27+49. (Permit No. 3811, 1962 - Inglin) [Additional Reference(s): DWR Levee Log, 1990 and 2005. USACE Sacramento O&M Manual Unit No. 127, June 1953, (Station 27+49)].
FS Date: 3/4/2014

Rip rap along waterward slope.

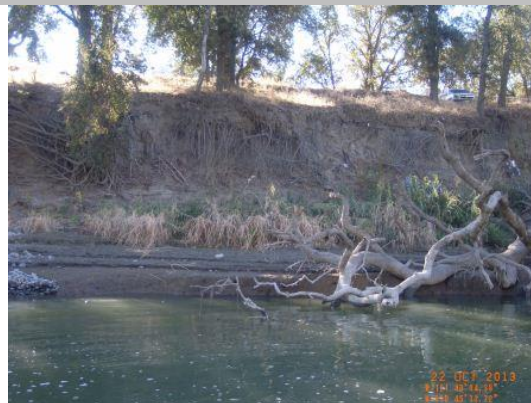
Photo 1 of 3 : SP_2017_NA0022_350_4_20170320_00003.jpg

LM Start	5.67	Rating **	M	Issue No.	4
LM End	5.85	Issue Type +	Ma	Location *	WS
Category	Supplemental			GPS Latitude/Longitude	
				Start	End
Item	2015 USACE Erosion Survey, DRAFT			38.759000°	38.759390°
				-121.670759°	-121.667500°
DWR ID	DWR_NA0022_01_s_2017_4				
Comment Code					
Inspector Comment					
2006 - Approximately 18 to 20 ft of bank near levee at the corner of the levee and the Freemont Weir. Vertical bank with undercutting/mass failure. 2007 - Staked at top of bank for monitoring. 2011 - Site has become significantly worse with more of the toe and lower bank eroded. Many trees have fallen since last year. 2012 - Site looks worse with more ersion around trees. 2013 - Additional erosion into the toe. 2015: Site extended upstream about 500 ft to account for eroding bank. [2015 Site ID: SAC 83-9 RI

USACE 2013 Photo #1

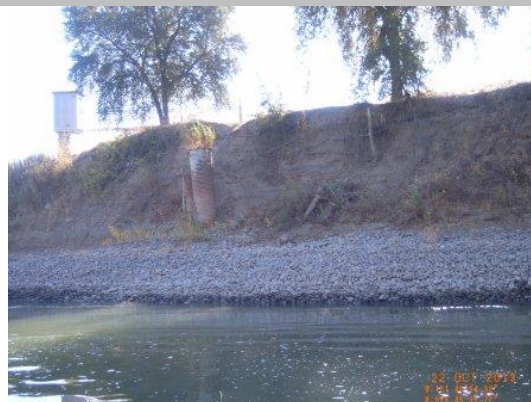
Photo 2 of 3 : SP_2017_NA0022_350_4_20170320_00004.jpg

USACE 2013 Photo #2

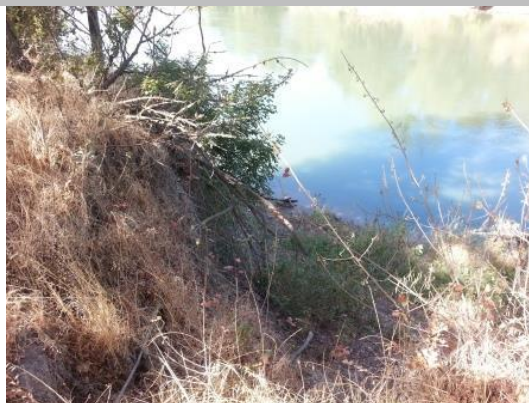
Photo 1 of 3 : SP_2017_NA0022_350_84_20170320_00065.jpg

LM Start	5.83	Rating **	U	Issue No.	84
LM End	5.83	Issue Type +	Ob	Location *	WS
Category	Earthen Levee			GPS Latitude/Longitude	
				Start	End
Item	Erosion / Bank Caving			38.758960 °	38.758960 °
				-121.668200 °	-121.668200 °
DWR ID	DWR_NA0022_01_s_2015_84				
Comment Code					
E1 : Note and monitor erosion site.					
Inspector Comment

View of an erosion site on waterward slope. Fall inspection 10/07/2016.
